Annual Inspection

Mid Suffolk District Council

Henley Community Centre (New)

Inspection Ref: 1933996

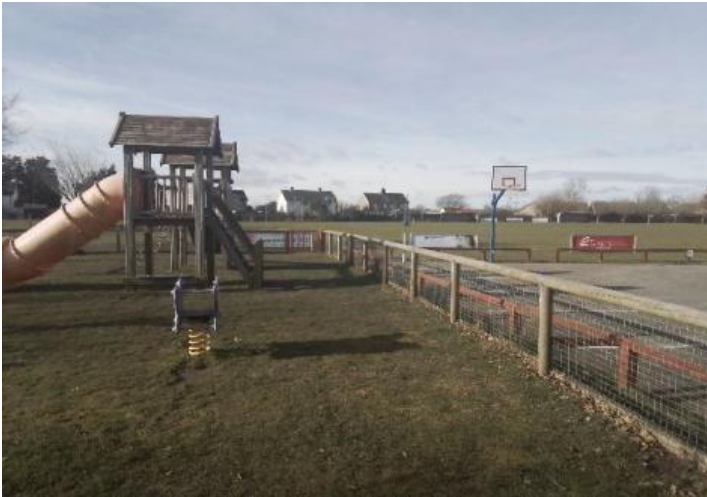
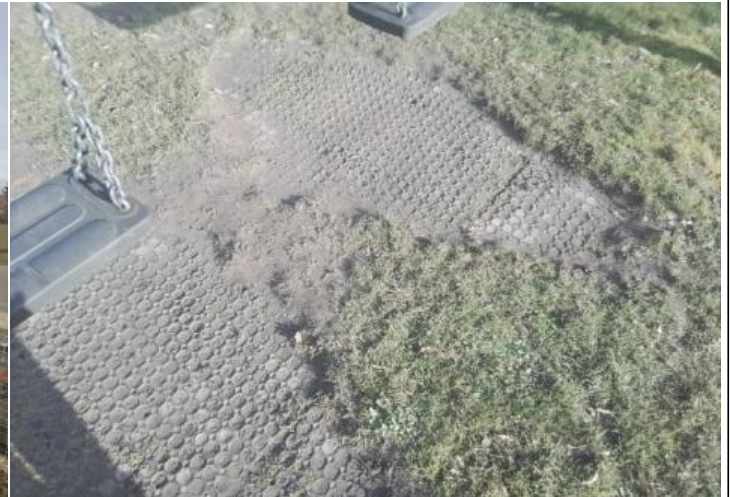
Finding: The grass mats are silted up, the soil is compacted and the area will become very slippery when the soil is wet. **Action:** Reinstate as required

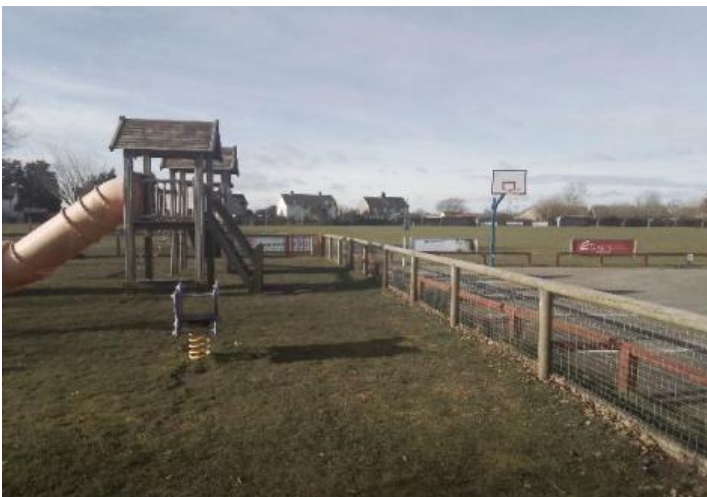
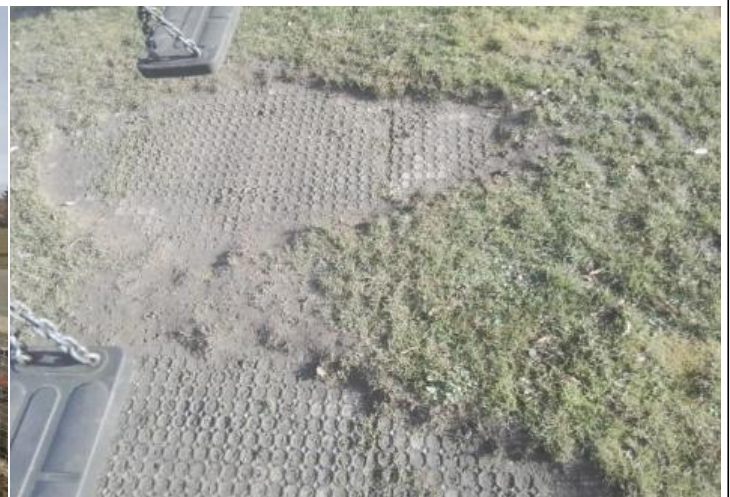
Finding: There are gaps opening between the grass mat tiles **Action:** Provide additional ties or secure / reinstate surface tiles

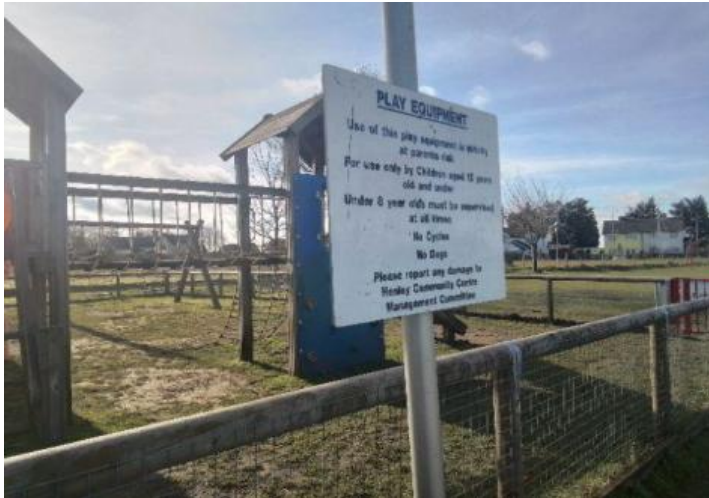
Finding: It is recommended that signage, with information including the site address, contact information for maintenance issues and emergency contact details are provided for the facility

Action: Provide in accordance with the recommendations

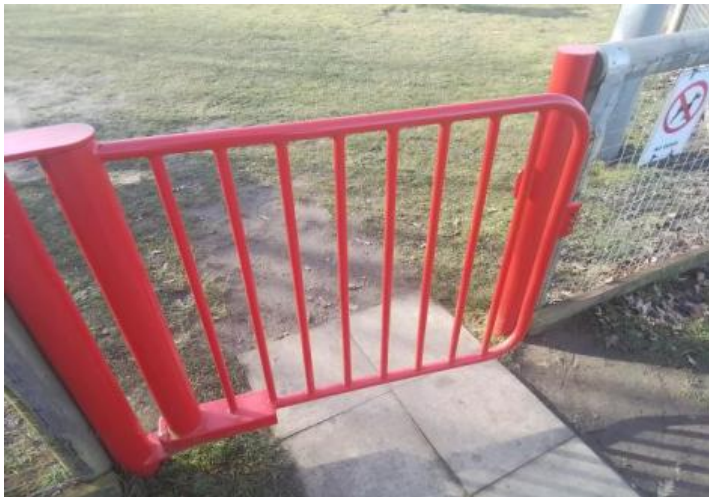
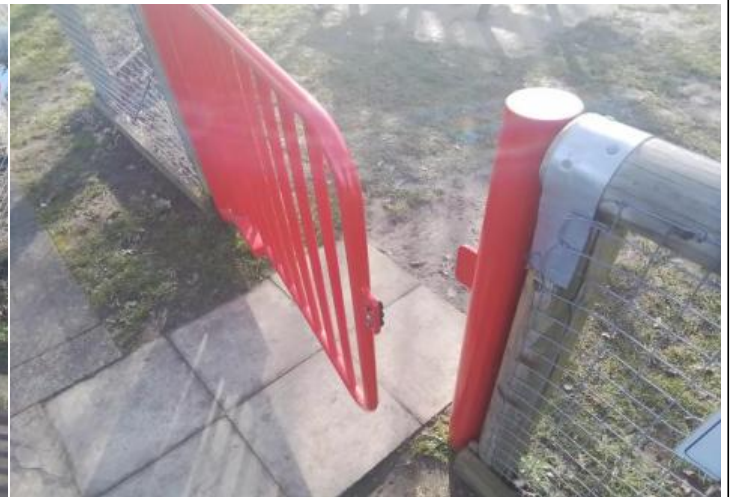
Finding: The gate is not operating correctly

Action: Take effective action to ensure the gate closes between 4 and 8 seconds

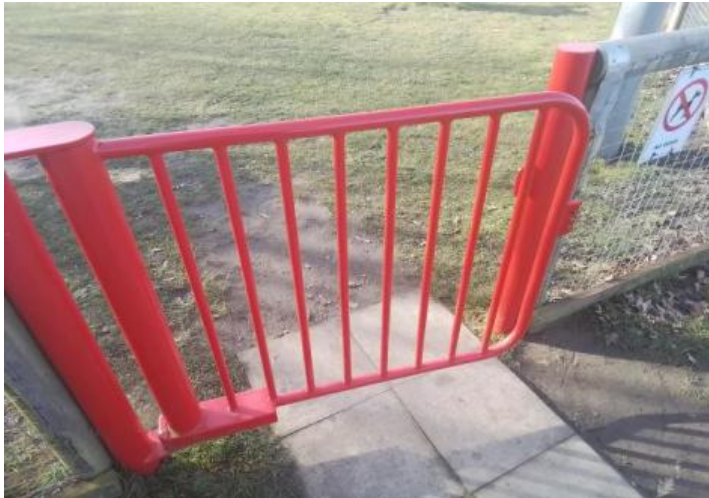
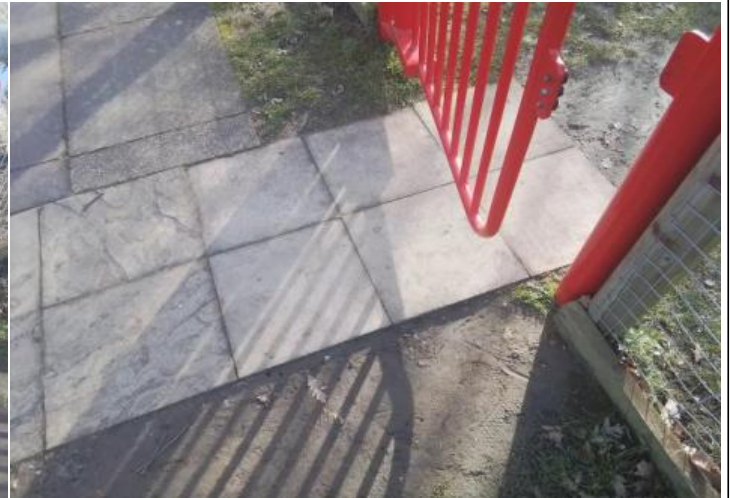
Finding: There are trip hazards present

Action: Reinstate surrounding surfaces to level to remove the trip points

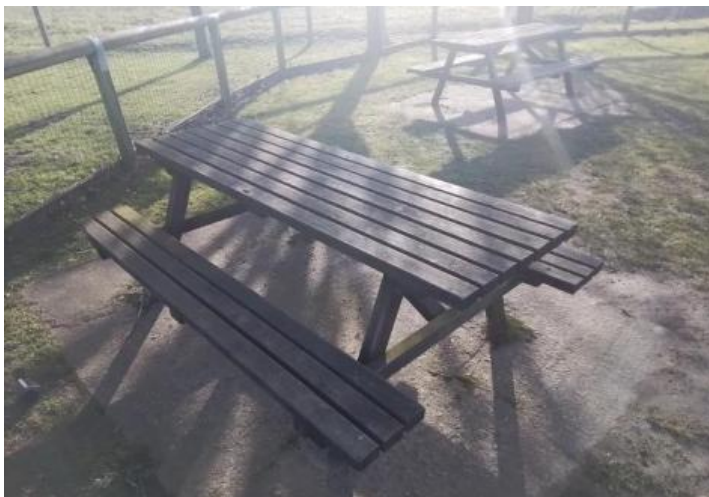
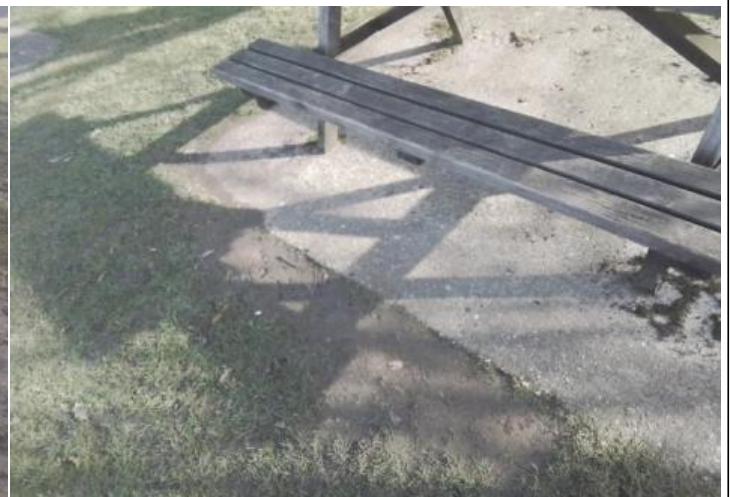
Finding: There are trip hazards present

Action: Reinstate surrounding surfaces to level to remove the trip points

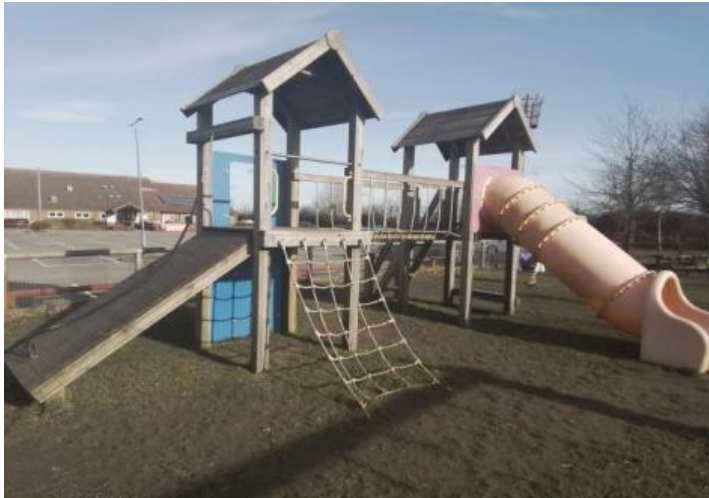
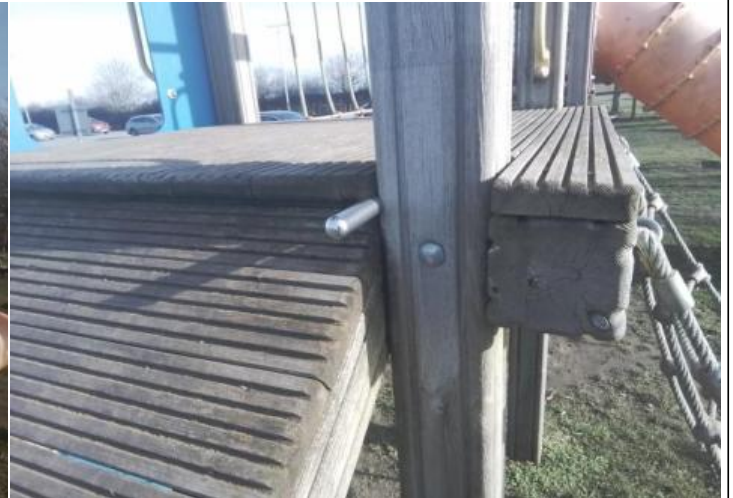
Finding: There is/are finger entrapment/s in the framework and the item fails to meet the requirements of BS EN 1176 Part 1 4.2.7.6 Entrapment of fingers

Action: Monitor - No remedial work recommended

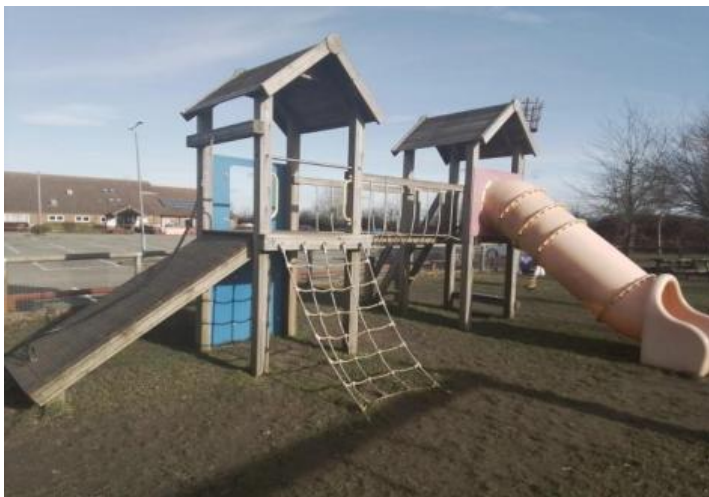
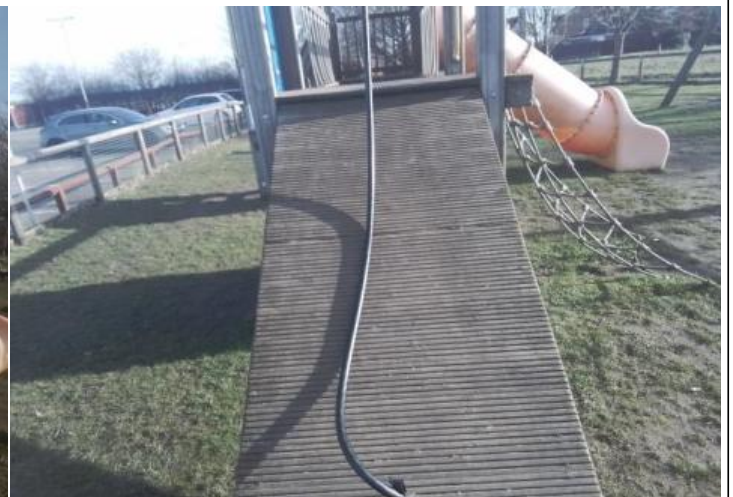
Finding: The chain connection cannot be inspected without dismantling the cover

Action: Dismantle the cover to inspect connection

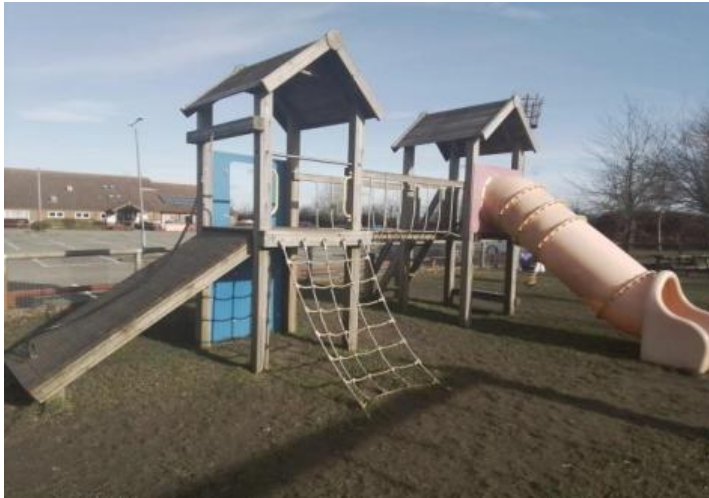
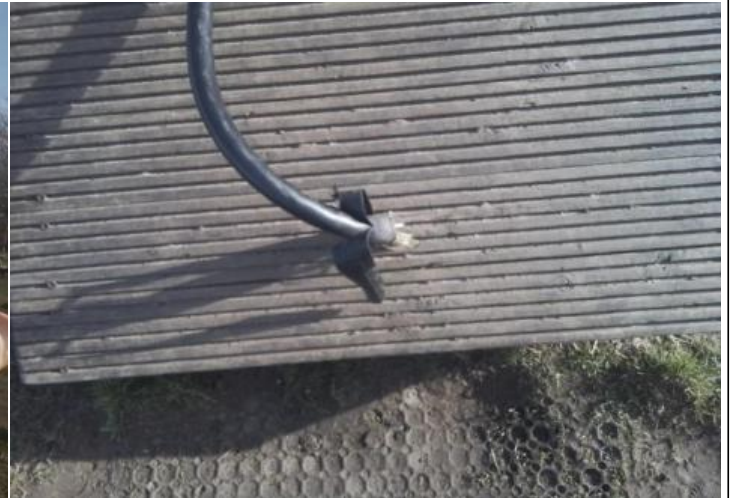
Finding: The suspension cover has been damaged

Action: Replace damaged item

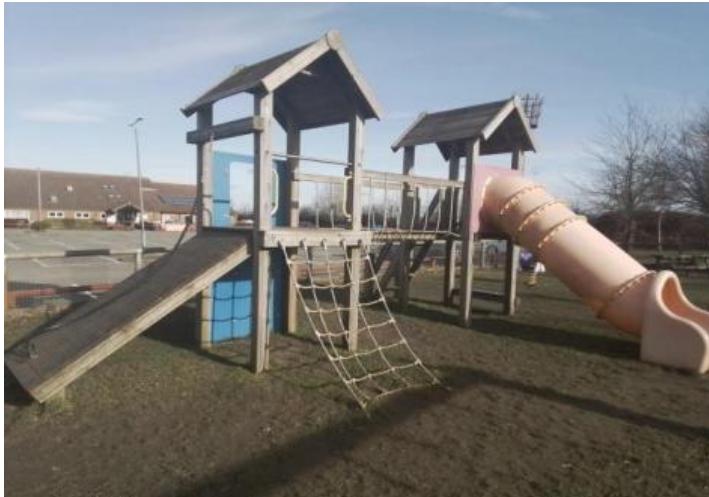
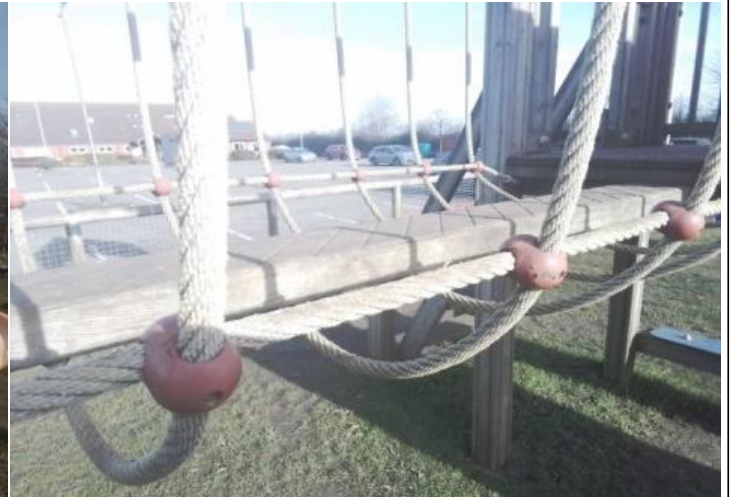
Finding: The ropes/nets are worn/damaged in places

Action: Monitor for any further deterioration and repair or replace as required

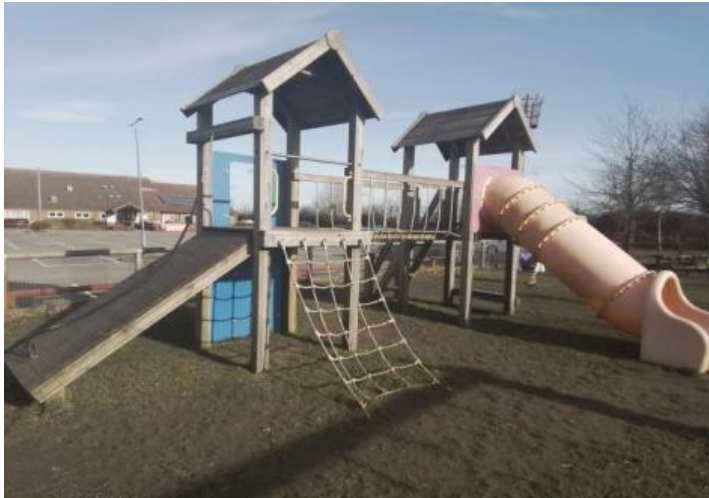
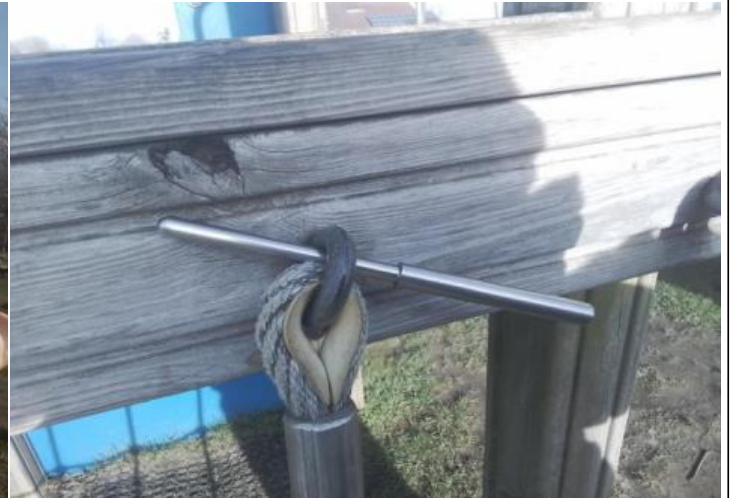
Finding: The connecting links are in excess of 8.6mm and less than 12mm and fail the requirements of BS EN 1176 Part 1; clause 4.2.13, Chains

Action: Monitor use and replace with compliant links at the next maintenance cycle

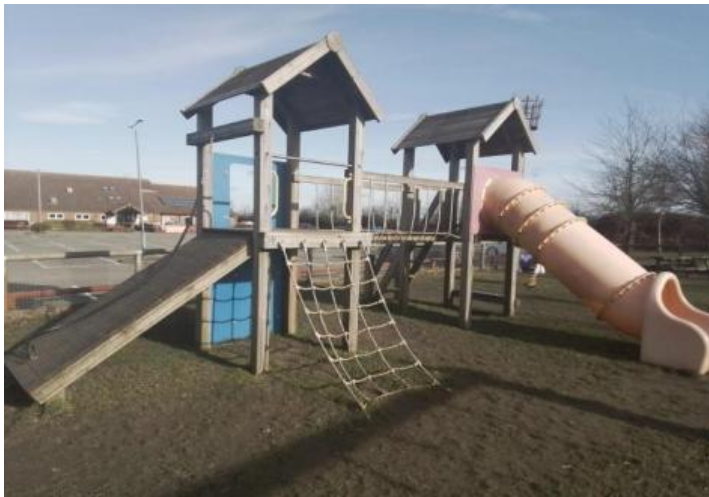
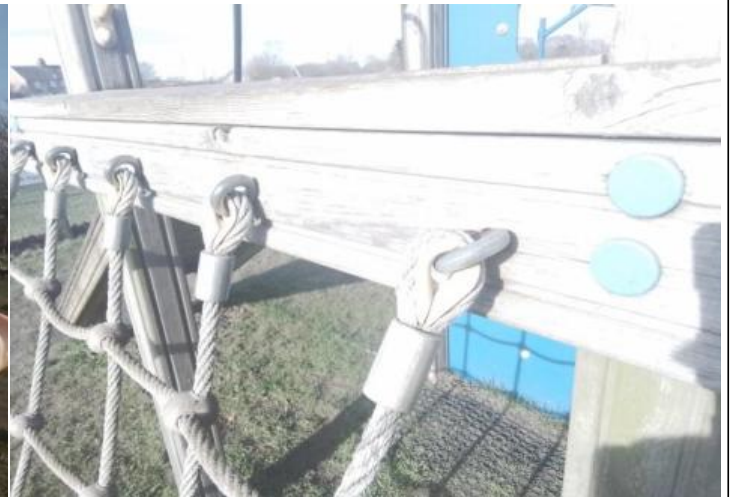
Finding: A number of fixing(s) have worked loose

Action: Secure all loose fixings

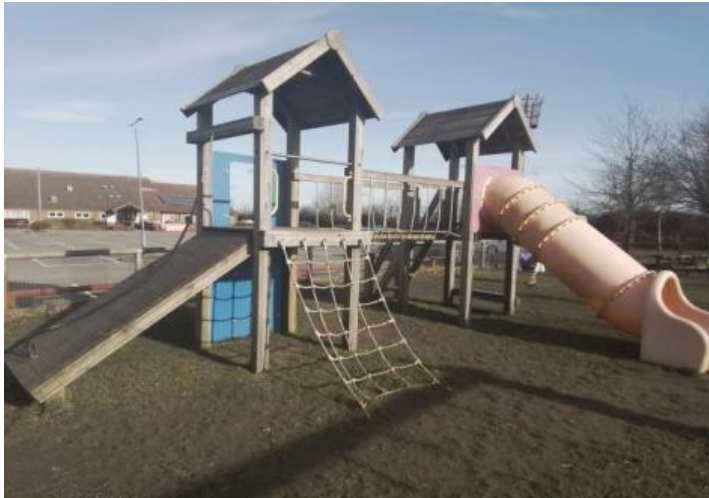
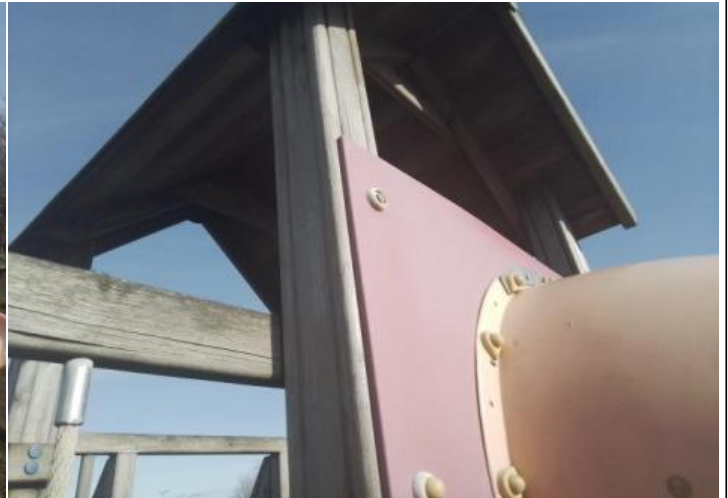
Finding: There is/are bolt cap covers missing or damaged on the item

Action: Replace missing or damaged bolt cap covers

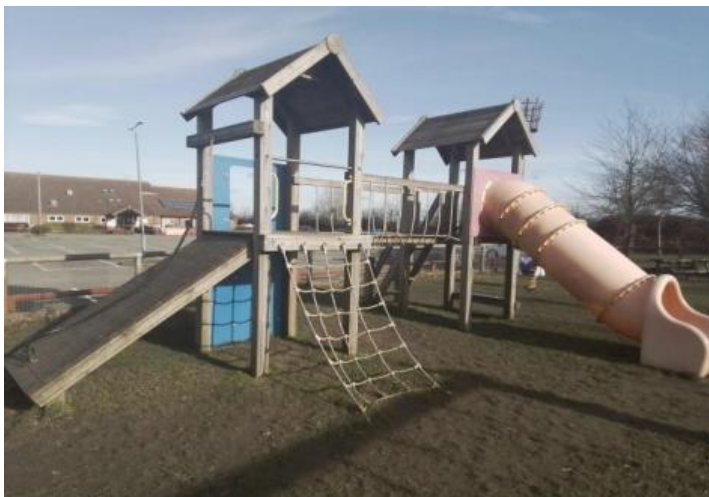
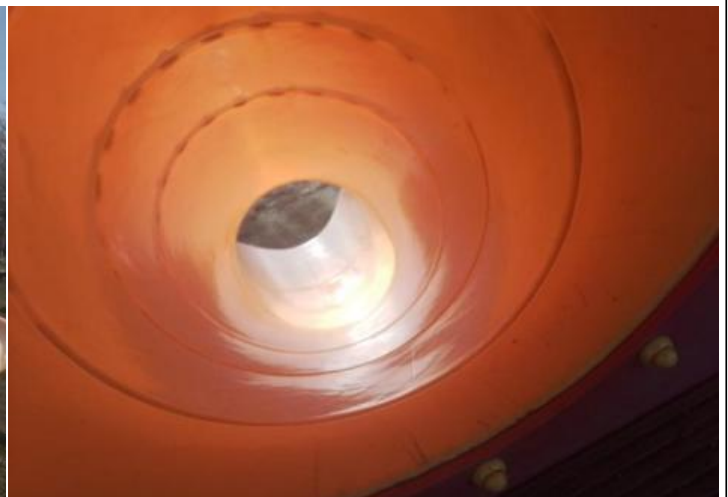
Finding: There is minor damage to the slide surface

Action: Monitor for any further deterioration and repair as required

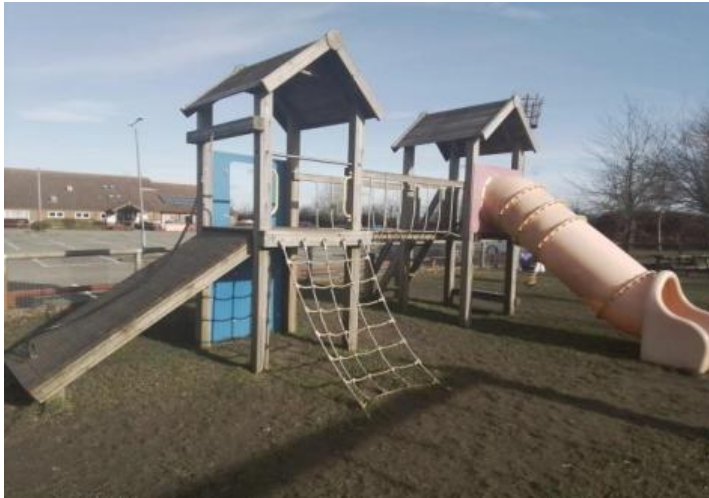
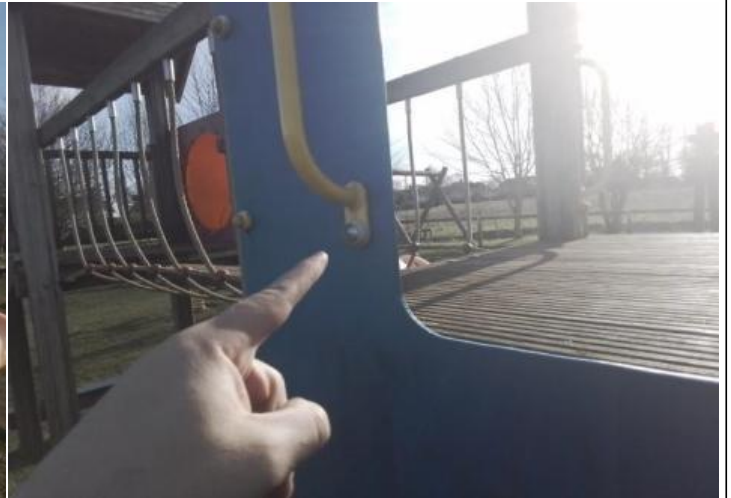
Finding: A number of barrier fixing(s) have worked loose

Action: Secure all loose fixings

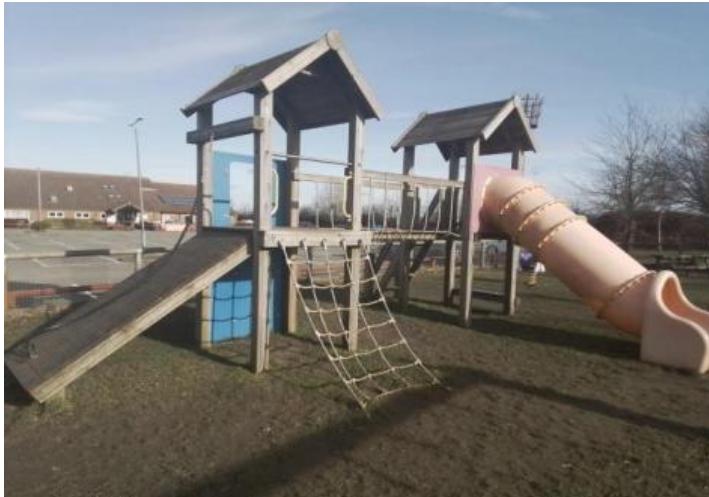
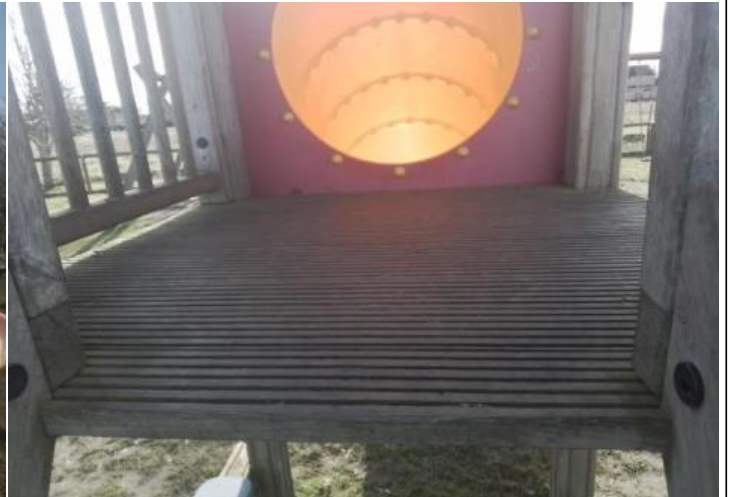
Finding: There is algae or moss on the surface of the equipment

Action: Clean and treat appropriately

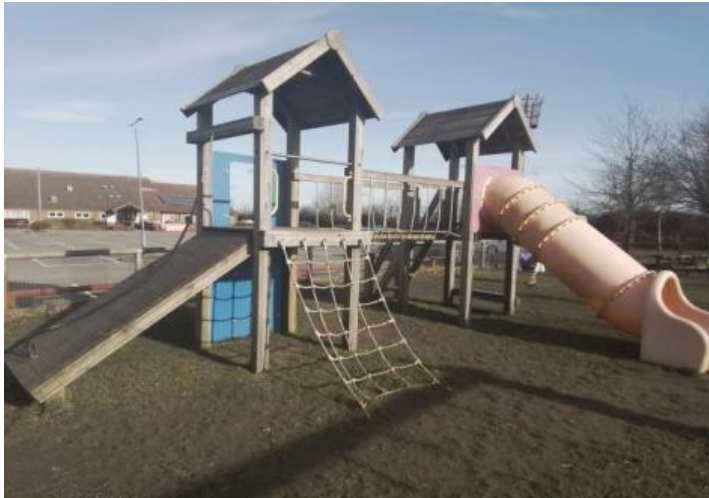
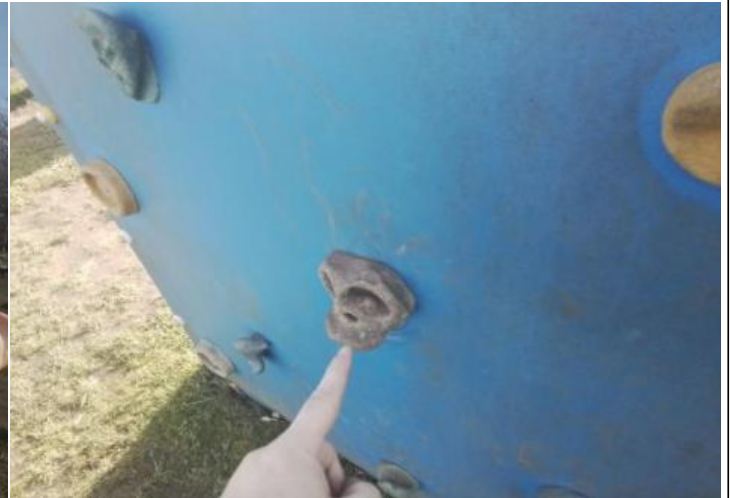
Finding: A number of handgrip fixing(s) have worked loose **Action:** Secure all loose fixings

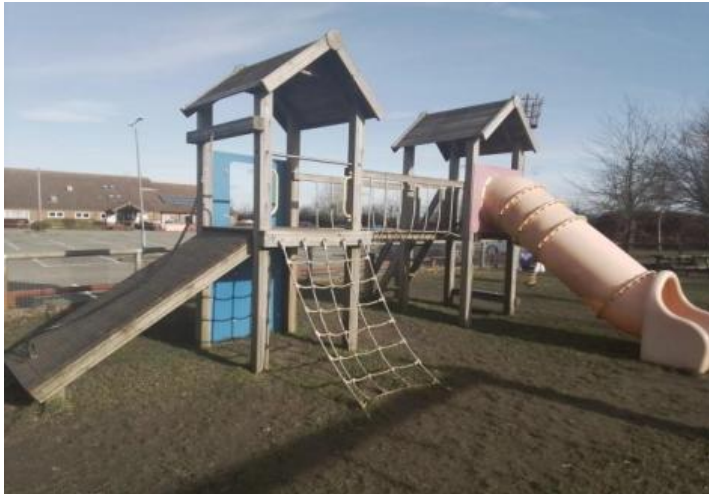
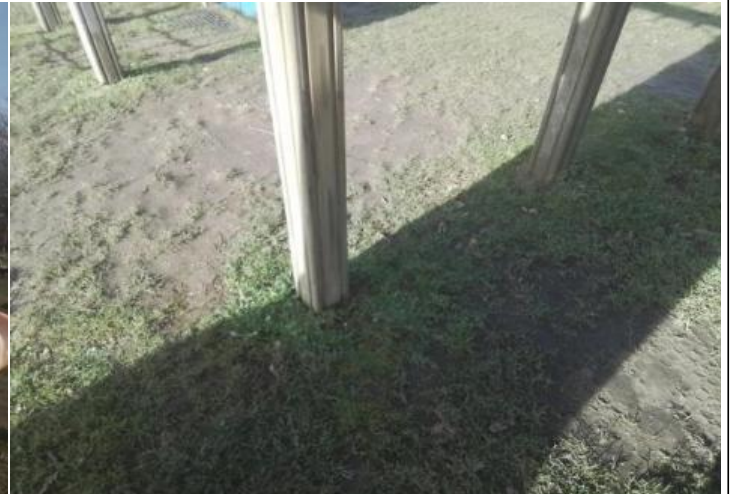
Finding: There is some evidence of rot in the timber **Action:** Monitor for any further deterioration and replace as required

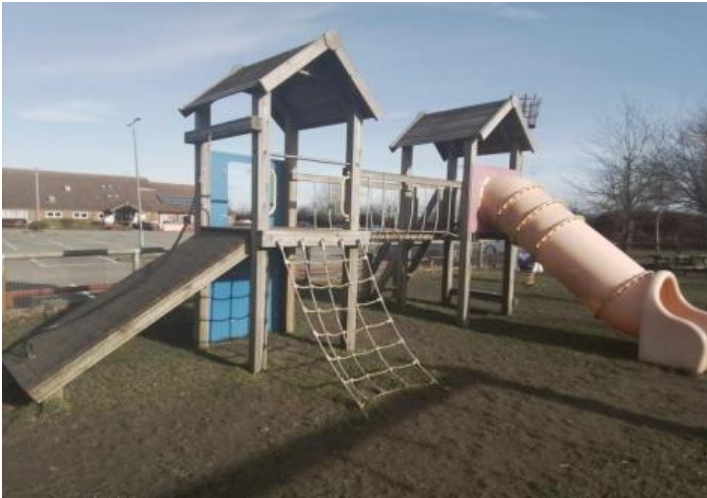
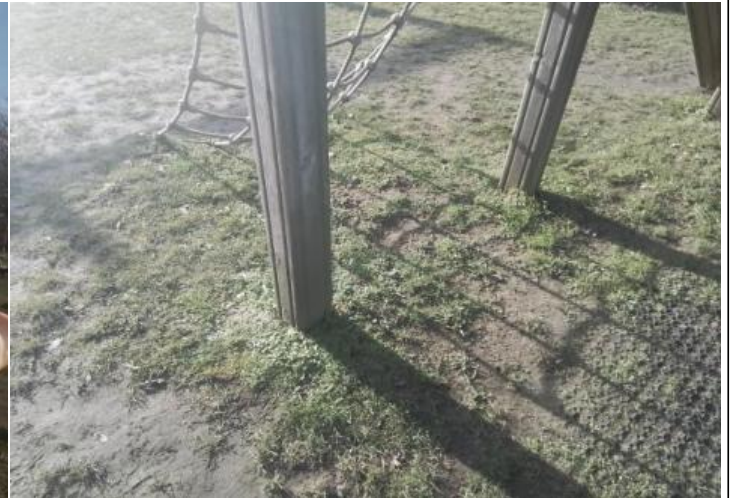
Finding: The timber stain is in poor condition

Action: Prepare all affected parts and re-stain with an appropriate preservative

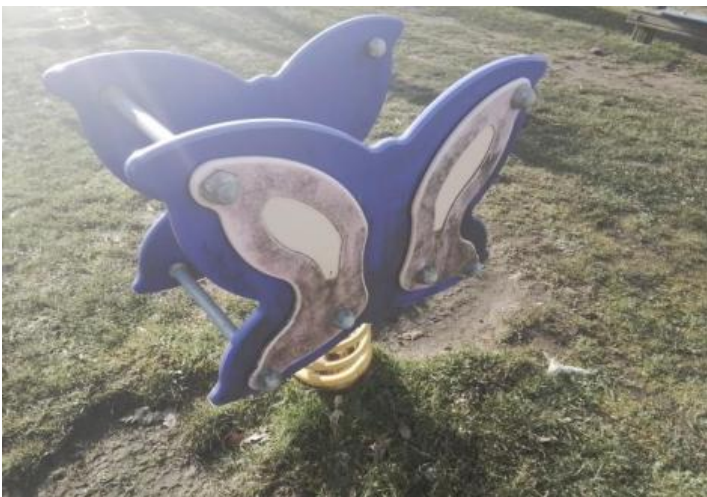
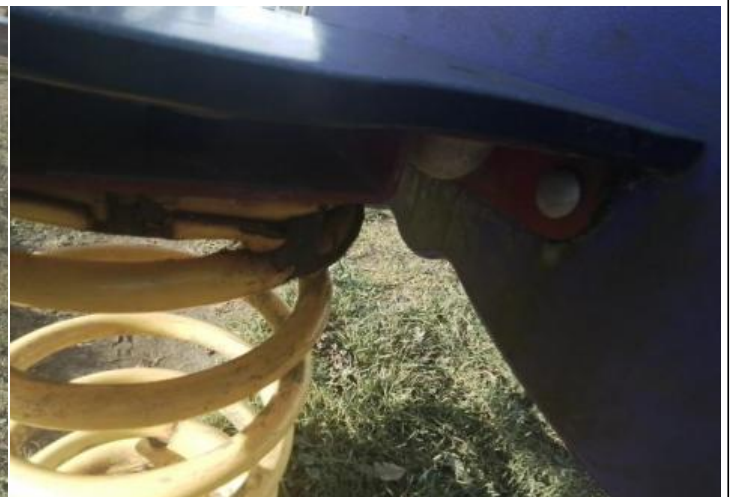
Finding: The paintwork on this item has been damaged or worn exposing the metal underneath which is rusting

Action: Treat any rusting components and repaint

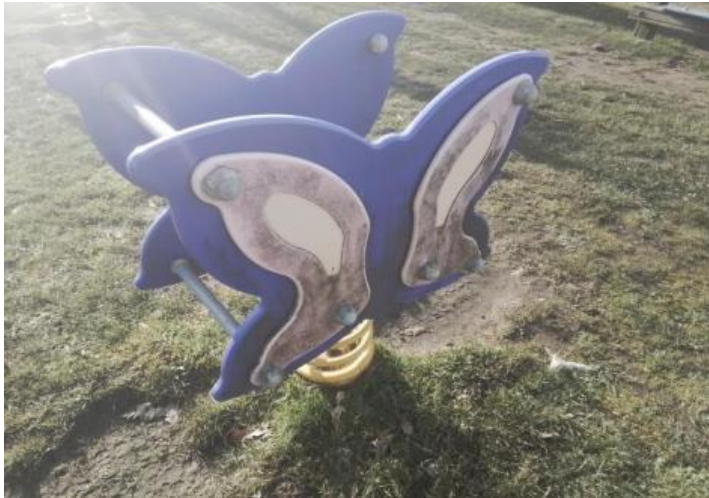
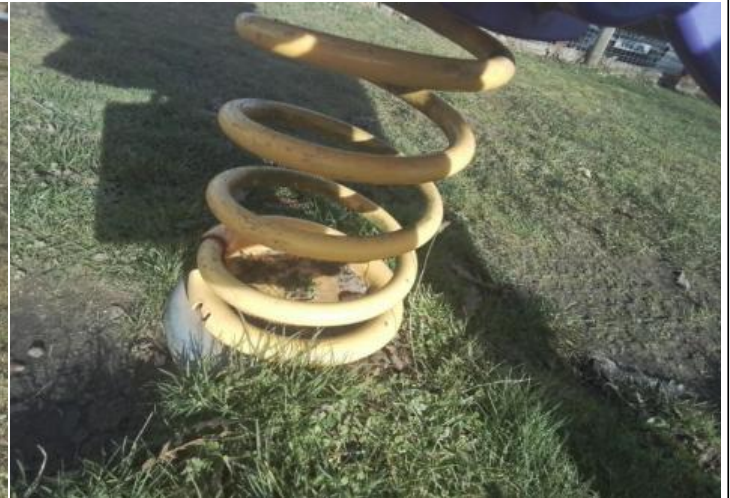
Finding: The item is slightly loose in its foundations

Action: Monitor for any further deterioration and repair as required

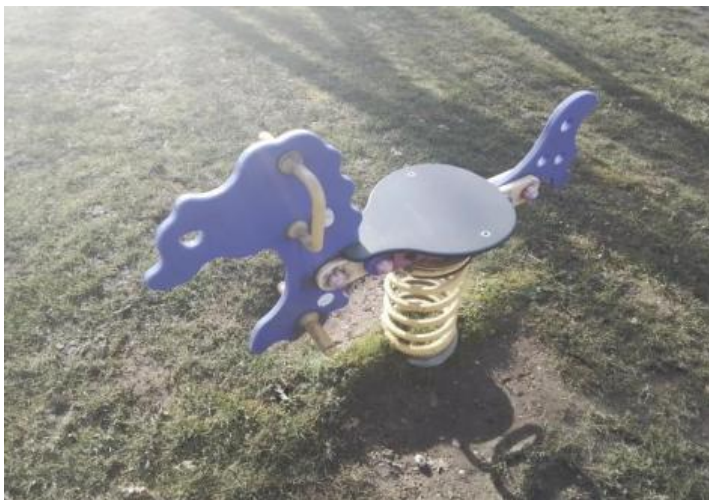
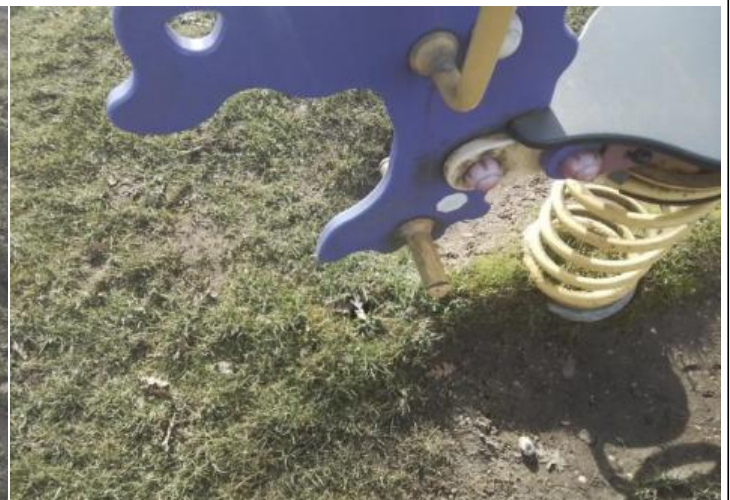
Finding: The end of handgrips and/or footrests have a cross section of less than 15cm² and fail to meet the requirements of BS EN 1176 Part 6

Action: Monitor - No remedial work recommended

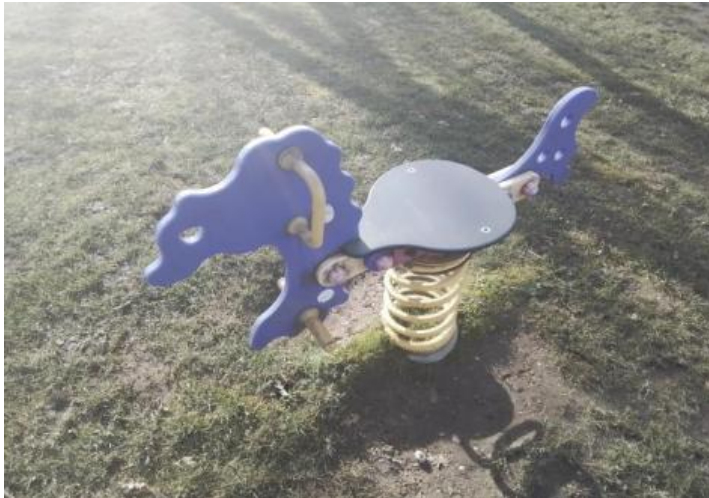
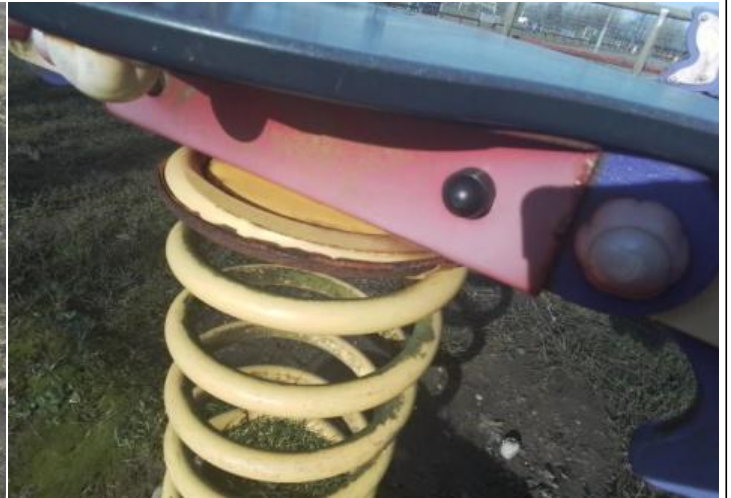
Finding: The paintwork on this item has been damaged or worn exposing the metal underneath which is rusting

Action: Treat any rusting components and repaint

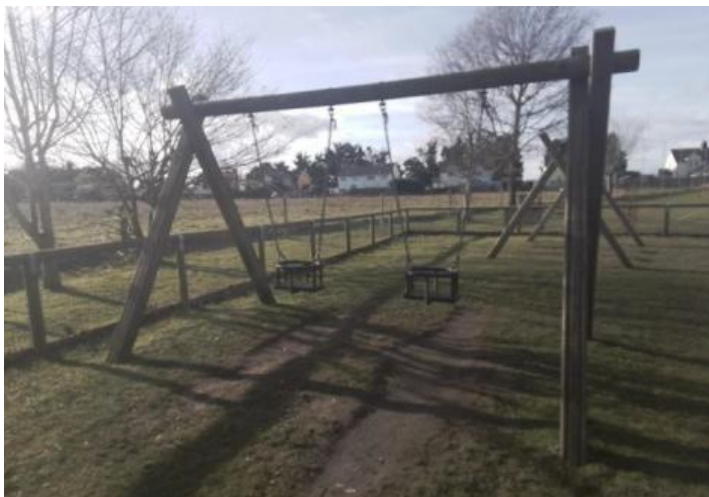
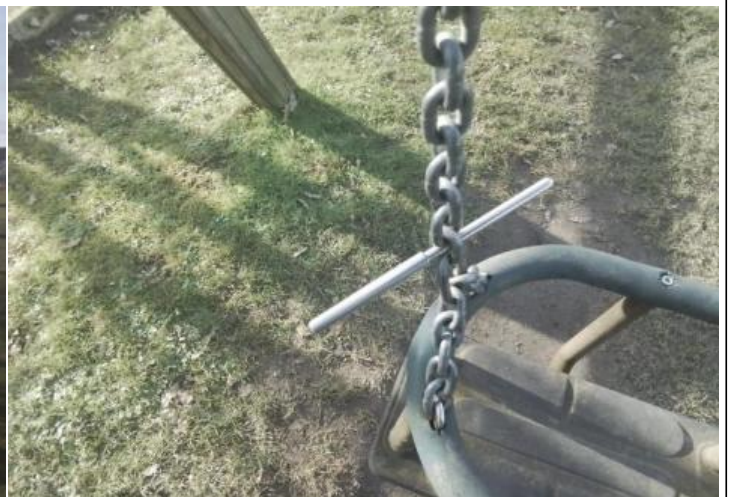
Finding: The chain openings are in excess of 8.6mm and do not meet the recommendations of BS EN 1176 Part 1

Action: Monitor - No remedial work recommended

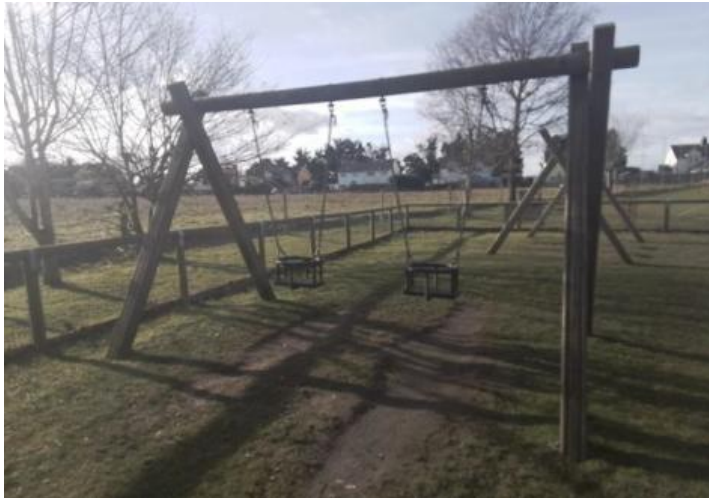
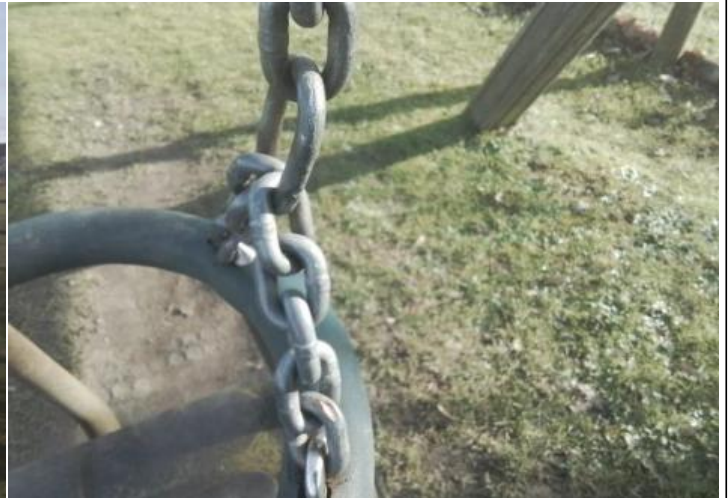
Finding: There is some notable evidence of chain wear

Action: Monitor for any further deterioration and replace when 40% worn

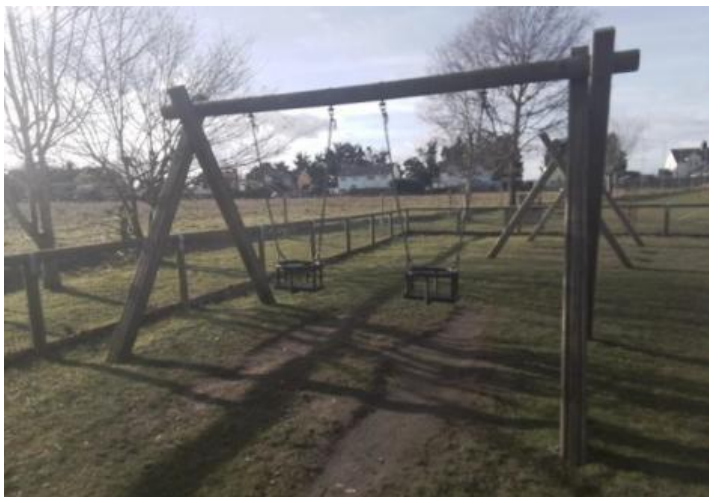
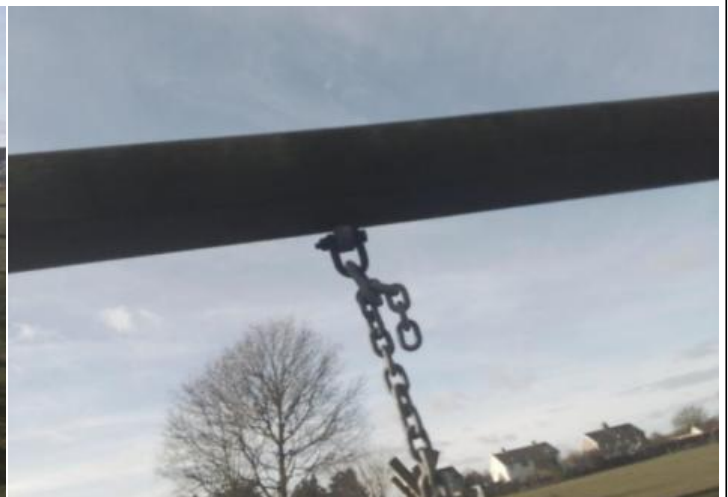
Finding: The bushes are showing signs of wear

Action: Monitor for any further deterioration and replace as required

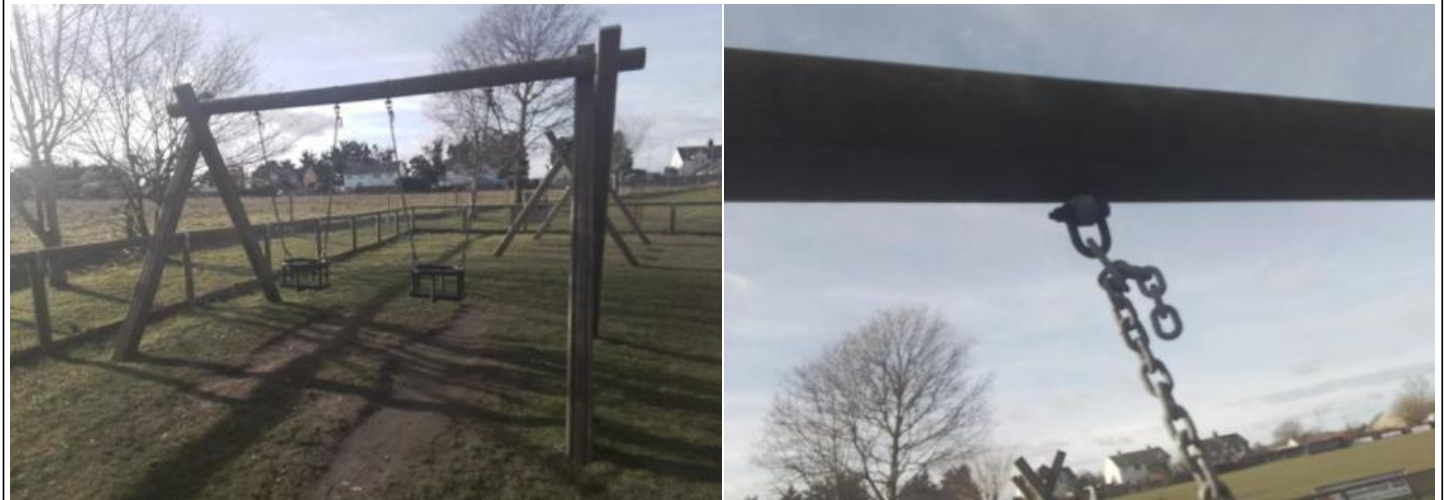
Finding: There is some wear to the shackles	Action: Monitor for any further deterioration and replace when 40% worn
--	--

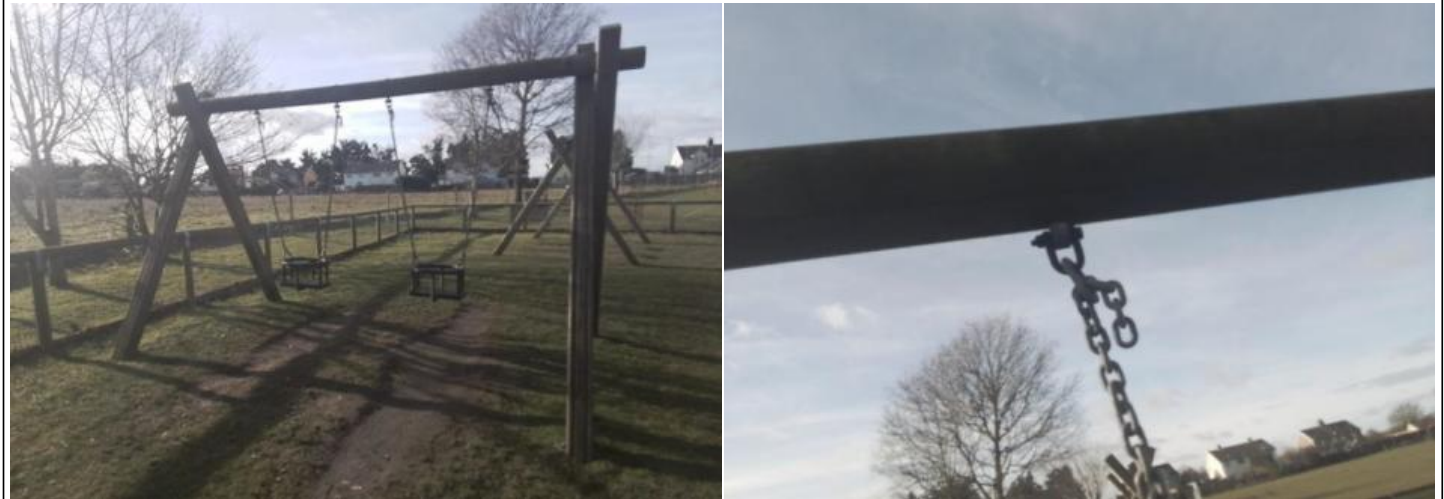
Finding: A number of suspension member fixing(s) have worked loose	Action: Secure all loose fixings
---	---

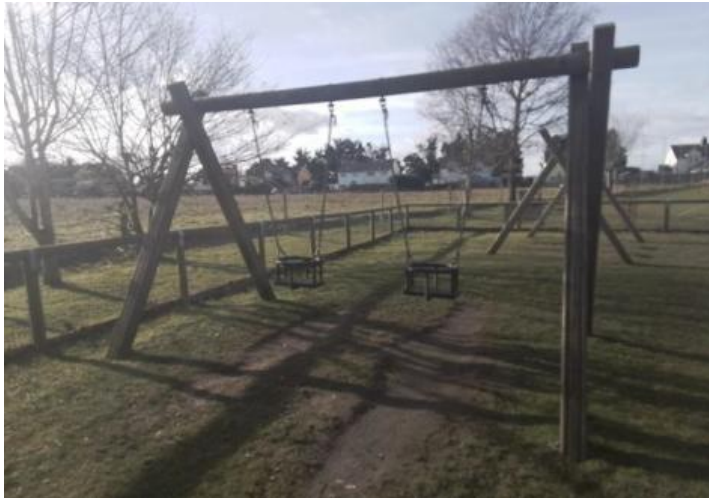
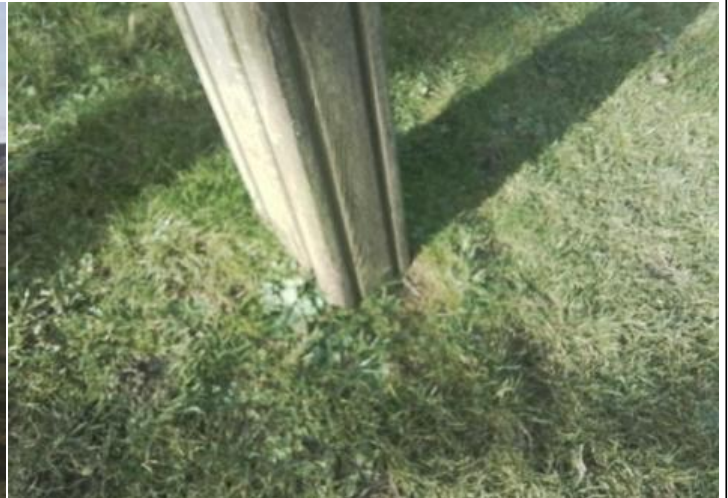
Finding: There is some strimmer / machinery damage apparent on the posts, this can penetrate the preservative applied to the timber and accelerate the rotting process

Action: Monitor for any deterioration (rot) and replace as required

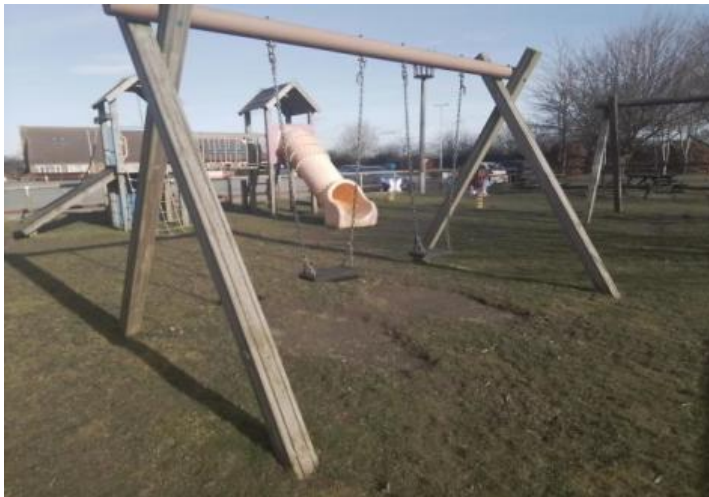
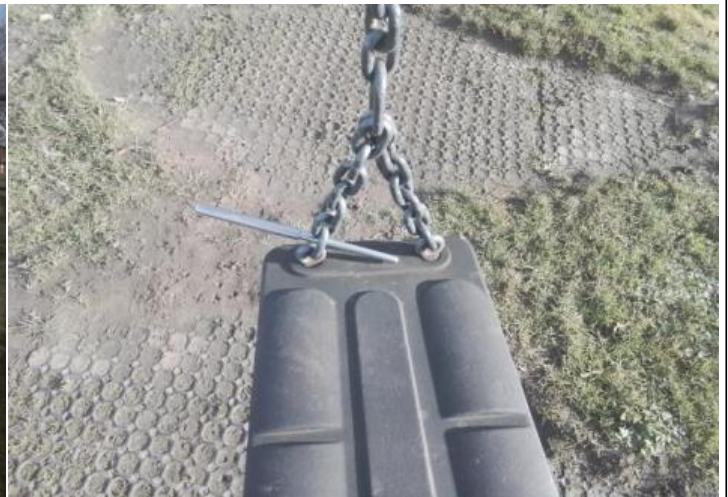
Finding: The chain openings are in excess of 8.6mm and do not meet the recommendations of BS EN 1176 Part 1

Action: Monitor - No remedial work recommended

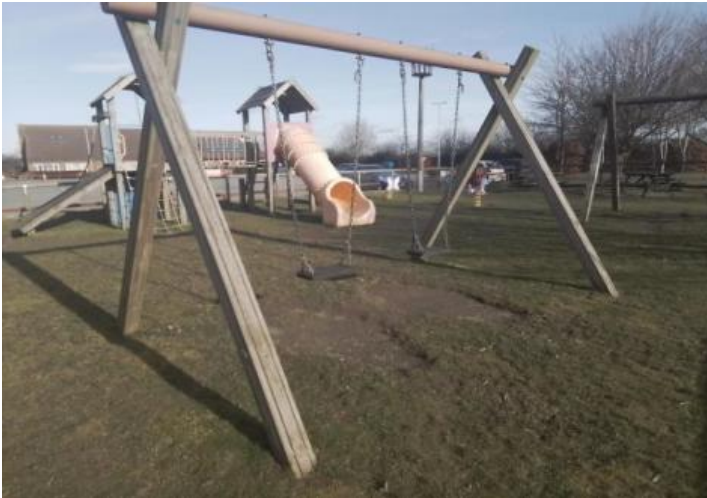
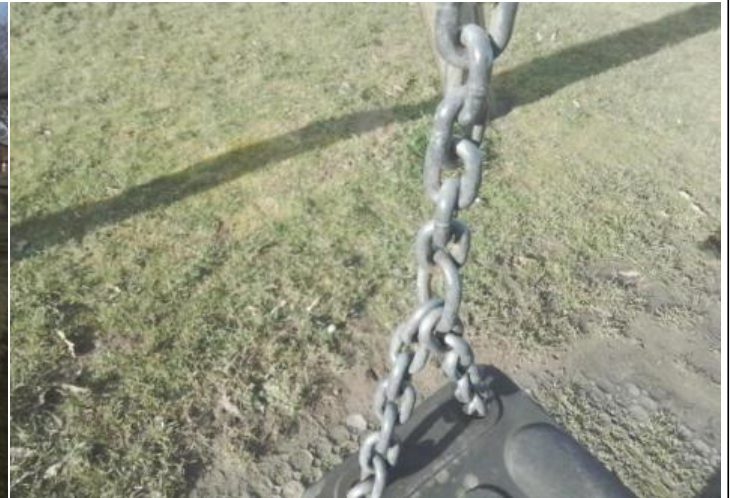
Finding: There is some notable evidence of chain wear

Action: Monitor for any further deterioration and replace when 40% worn
