Annual Inspection

Mid Suffolk District Council

Henley Community Centre (New)

Inspection Ref: 1933996

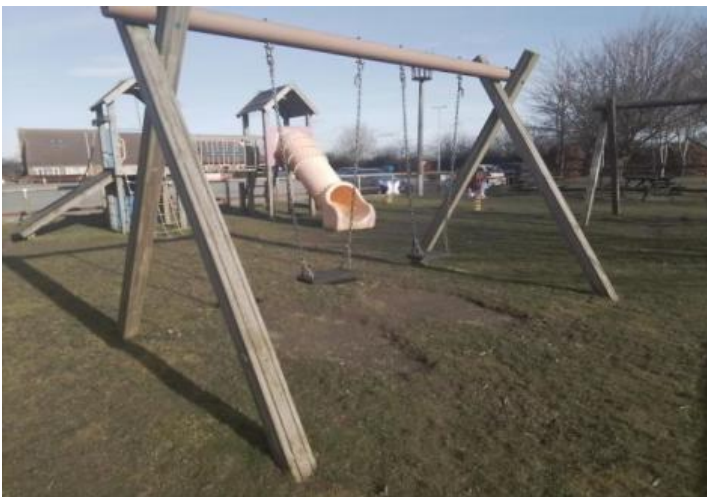
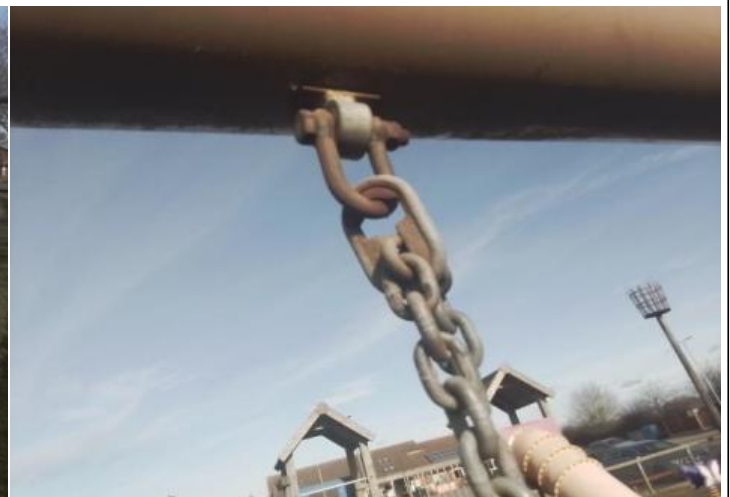
Finding: There is some wear to the shackles

Action: Monitor for any further deterioration and replace when 40% worn

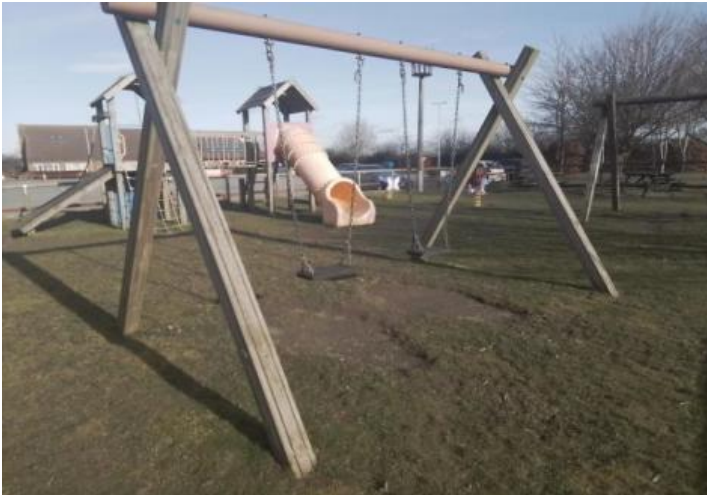
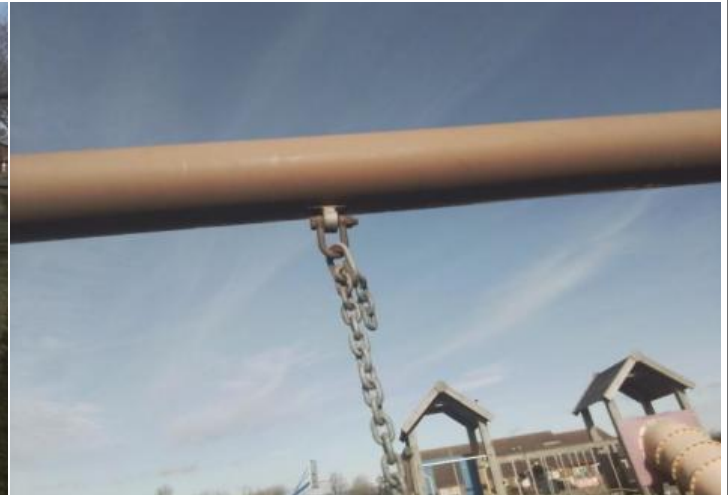
Finding: The bushes are showing signs of wear

Action: Monitor for any further deterioration and replace as required

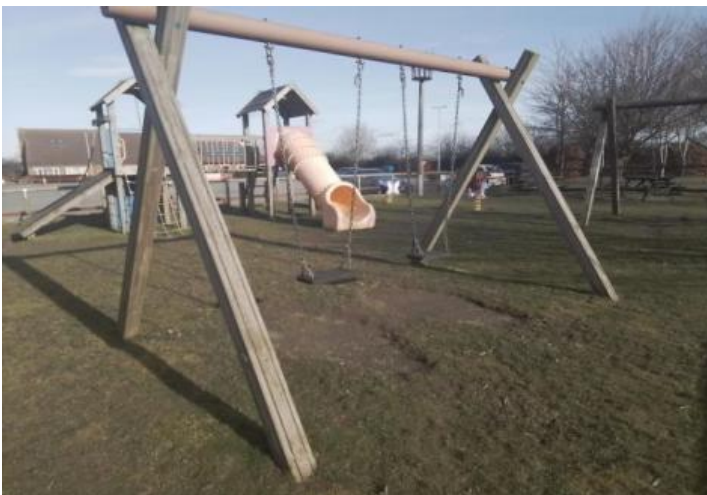
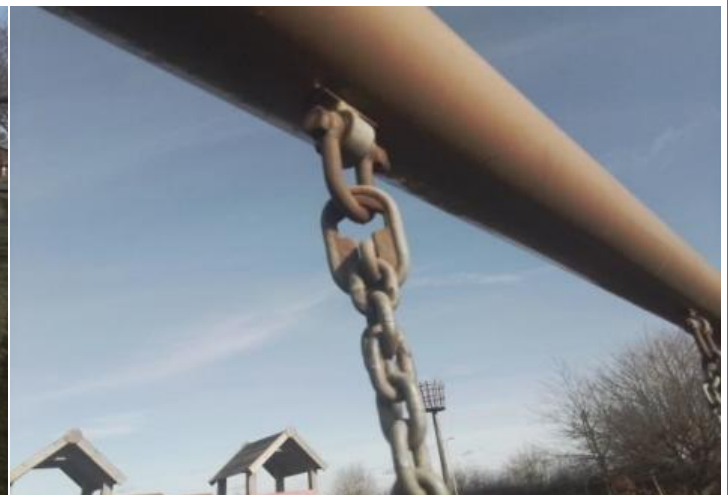
Finding: A number of suspension members fixing(s) have worked loose

Action: Secure all loose fixings

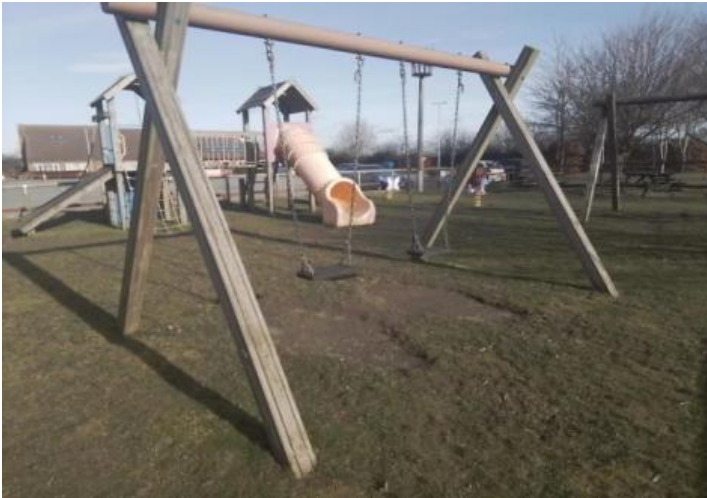
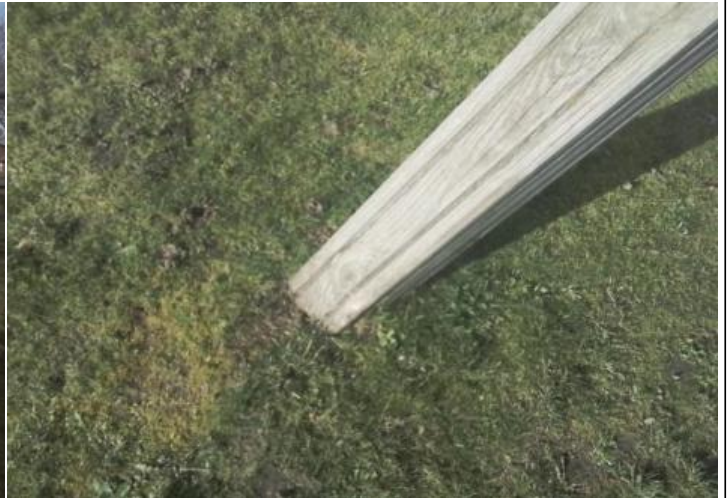
Finding: There is some strimmer / machinery damage apparent on the posts, this can penetrate the preservative applied to the timber and accelerate the rotting process

Action: Monitor for any deterioration (rot) and replace as required
