Annual Inspection

Mid Suffolk District Council

Henley Community Centre (New)

Inspection Ref: 1933996

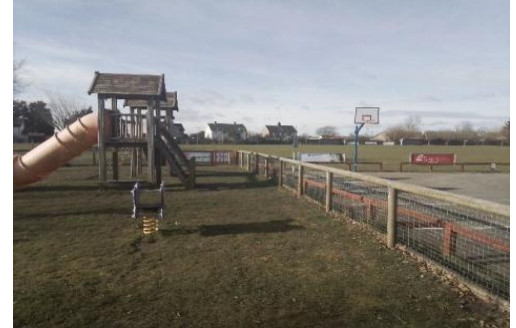
Item: Site General
Manufacturer: Owner/Operator
Surface Type: N/A
Item Quantity: 1
Equipment Compliance: N/A
Surface Area Compliance: N/A

Finding 1

The grass mats are silted up, the soil is compacted and the area will become very slippery when the soil is wet. - Reinststate as required

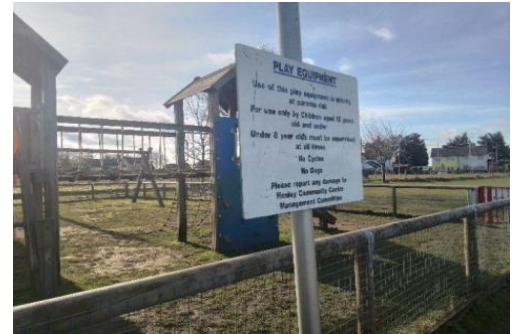
Item: Sign
Manufacturer: Owner/Operator
Surface Type: N/A
Item Quantity: 1
Equipment Compliance: N/A
Surface Area Compliance: N/A

Finding 1

It is recommended that signage, with information including the site address, contact information for maintenance issues and emergency contact details are provided for the facility - Provide in accordance with the recommendations

i 8 - Low Risk

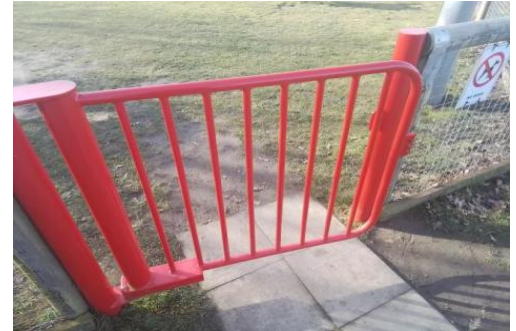
Item: Gate - Self Closing
Manufacturer: Not Identified
Surface Type: Paving Slabs
Item Quantity: 1
Equipment Compliance: N/A
Surface Area Compliance: N/A

There are trip hazards present - Reinstate surrounding surfaces to level to remove the trip points

i 4 - Very Low Risk

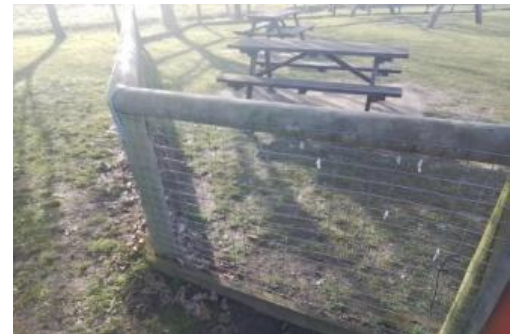
Item: Fence - Timber & Mesh Infill
Manufacturer: Not Identified
Surface Type: Grass
Item Quantity: 1
Equipment Compliance: N/A
Surface Area Compliance: N/A

i 4 - Very Low Risk

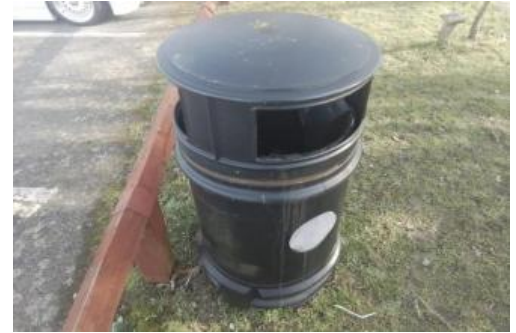
Item: Litter Bin
Manufacturer: Not Identified
Surface Type: Grass
Item Quantity: 1
Equipment Compliance: N/A
Surface Area Compliance: N/A

i 8 - Low Risk

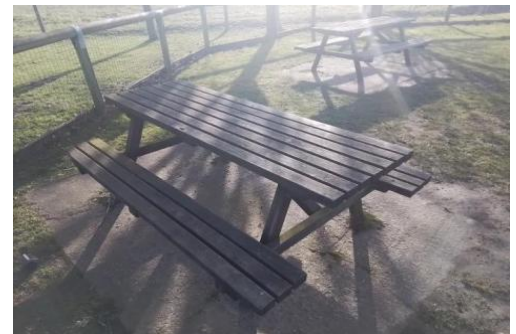
Item: Picnic Table
Manufacturer: Not Identified
Surface Type: Concrete
Item Quantity: 1
Equipment Compliance: N/A
Surface Area Compliance: N/A

Finding 1

There are trip hazards present - Reinstate surrounding surfaces to level to remove the trip points

i 6 - Low Risk

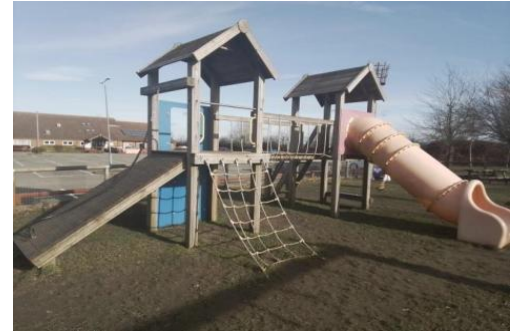
Item: Multi Play (Junior)
Manufacturer: Wicksteed Playgrounds
Surface Type: Grass Matrix Tiles
Item Quantity: 1
Equipment Compliance: No
Surface Area Compliance: Yes

Finding 1

There is/are finger entrapment/s in the framework and the item fails to meet the requirements of BS EN 1176 Part 1 4.2.7.6 Entrapment of fingers - Monitor - No remedial work recommended

The suspension cover has been damaged - Replace damaged item

i 6 - Low Risk

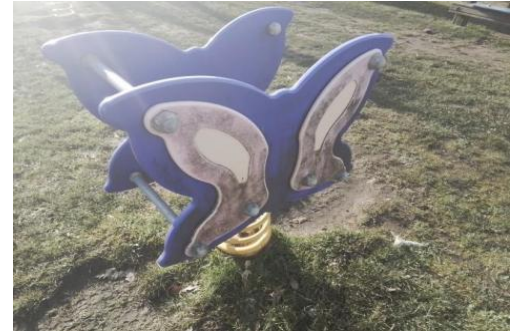
Item: Spring Butterfly
Manufacturer: Wicksteed Playgrounds
Surface Type: Grass Matrix Tiles
Item Quantity: 1
Equipment Compliance: Yes
Surface Area Compliance: Yes

i 6 - Low Risk

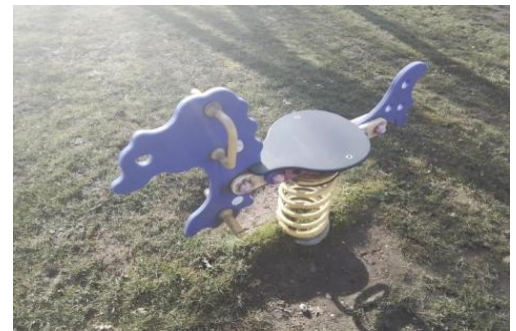
Item: Spring Dog
Manufacturer: Wicksteed Playgrounds
Surface Type: Grass Matrix Tiles
Item Quantity: 1
Equipment Compliance: No
Surface Area Compliance: Yes

i 8 - Low Risk

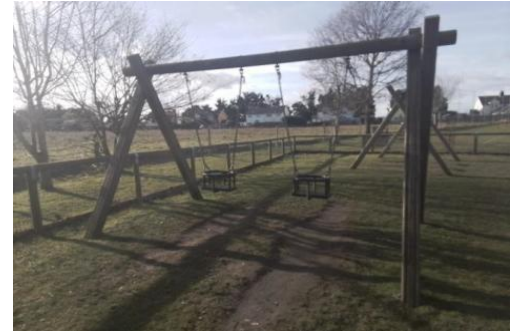
Item: 1 Bay 2 Seat (Cradle)
Manufacturer: Wicksteed Playgrounds
Surface Type: Grass Matrix Tiles
Item Quantity: 1
Equipment Compliance: No
Surface Area Compliance: Yes

i 6 - Low Risk

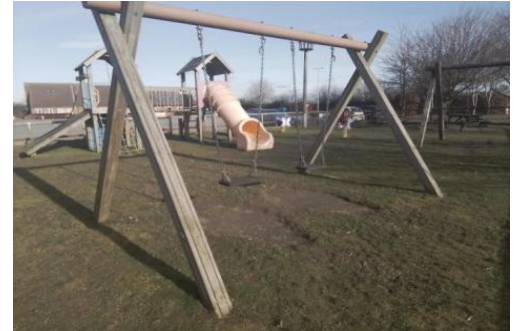
Item: 1 Bay 2 Seat (Flat)
Manufacturer: Wicksteed Playgrounds
Surface Type: Grass Matrix Tiles
Item Quantity: 1
Equipment Compliance: No
Surface Area Compliance: Yes

i 4 - Very Low Risk
